Virginia Department of Forestry BMP Effort, Implementation, and Effectiveness Field Audit

•
June 2005

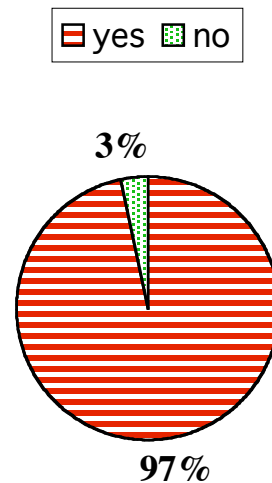
Efforts to implement BMPs were evident at 97% of inspected timber harvests, down from the 100% recorded in November 2004, (*fig.1*). Quality of effort, rated on a scale of 1(poor) to 5(excellent), averaged 3.0, up from the 2.7 average of November 2004. Implementation of all necessary BMPs to DOF standards occurred at

Fig. 1: Has An Effort Been Made To Apply BMPs, Regardless Of Meeting Technical Specifications?

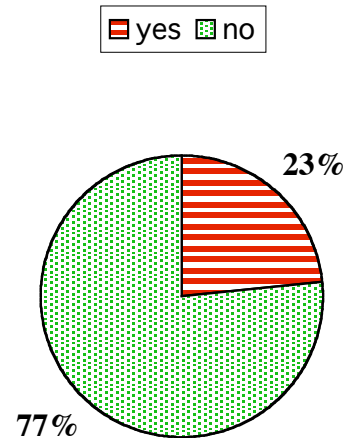
23% of inspected sites, up from the 10% recorded in November 2004 (*fig. 2*).

Fig. 2: Were All BMPs Applied To Technical Specifications As Expressed in The BMP Manual?

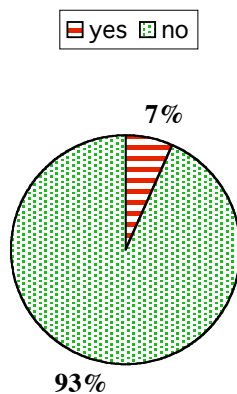
Active sedimentation existed at 7% of the inspected sites, down from the 14% recorded in November 2004, (*fig. 3*). The potential for sedimentation was noted at 13% of the inspected

Fig. 3: Does Active Sedimentation Exist Now Because BMP Technical Specifications Were Not Met?

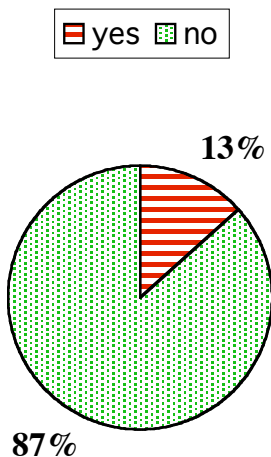
sites, down from the 14% noted in November 2004, (fig. 4).

Fig. 4: Does The Potential Exist For Active Sedimentation To Develop Because BMP Technical Specifications Were Not Met?
